# Development of a simplified procedure for penstock risk assessment

## 3 Case study

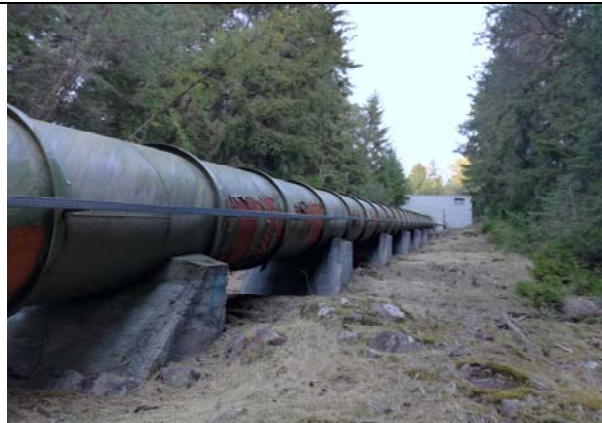
| # | Plant | P<br>MW | Type of<br>penstock | Joint | Lie-down | Critical cause | O | D | S | RPN |
|---|---|---|---|---|---|---|---|---|---|---|
| 12 | Sarentino | 24.5 | Steel pipe | Welded | Saddle and<br>anchor blocks | Failure of<br>constraints | 3 | 1 | 3 | 9 |

*Sarentino HPP – shell conditions*

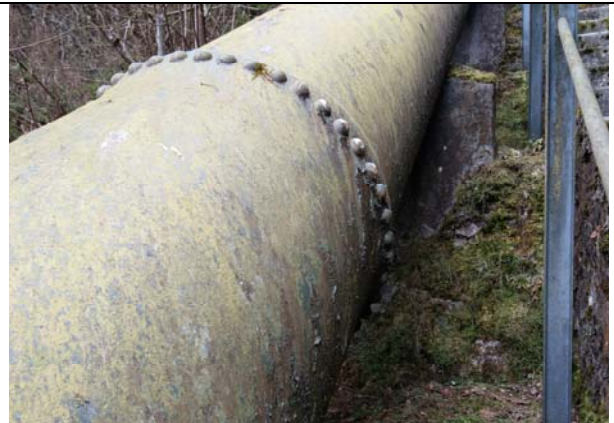
| # | Plant | P<br>MW | Type of<br>penstock | Joint | Lie-down | Critical cause | O | D | S | RPN |
|---|---|---|---|---|---|---|---|---|---|---|
| 14 | Premesa | 8.2 | Steel pipe | Welded<br>+riveted | Saddle and<br>anchor blocks | Failure of pipe<br>shell | 2.5 | 1 | 2 | 5 |

*Premesa HPP – type of connections*

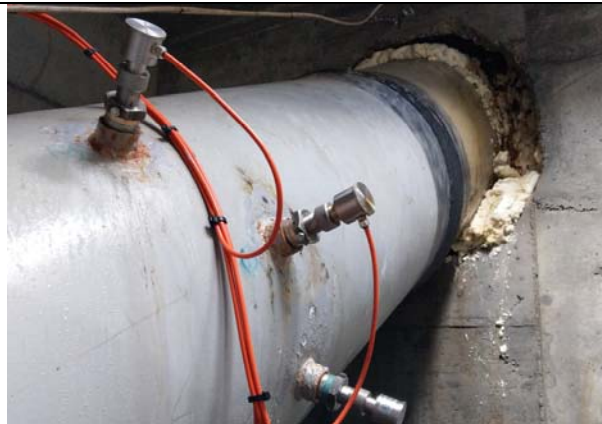
*Selva Gardena HPP – differential detection system (D=1)*

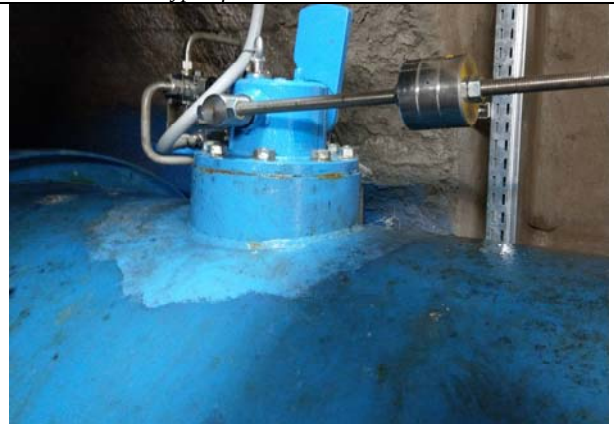
*Ponte Gardena HPP – Paddle-Type Flow Switch (D=2)*

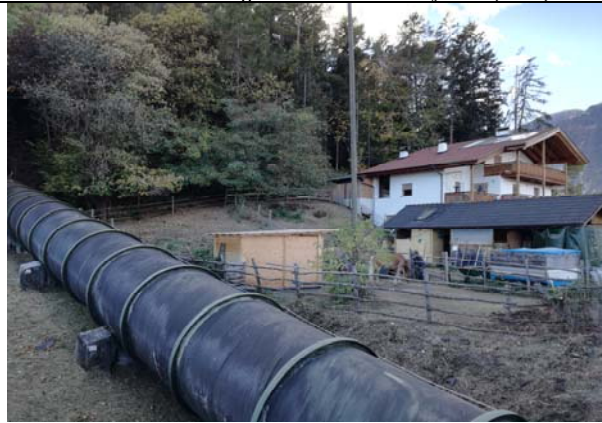
*Lana HPP – Private houses close to the penstock*

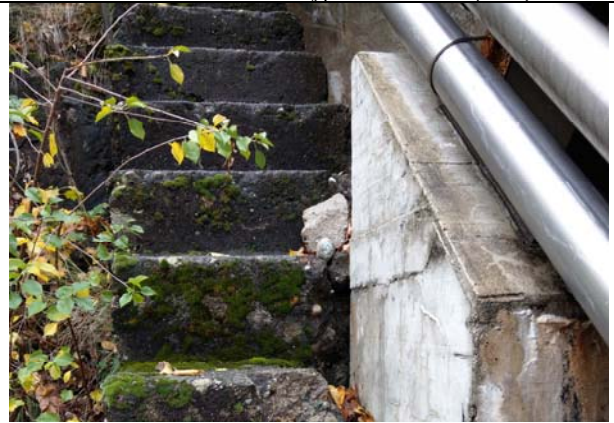
| # | Plant | P<br>MW | Type of<br>penstock | Joint | Lie-down | Critical cause | O | D | S | RPN |
|---|---|---|---|---|---|---|---|---|---|---|
| 1 | Bolzano<br>EGA | 4.2 | Steel pipe | Welded | Saddle and<br>anchor blocks | Failure of pipe<br>shell | 2.25 | 4 | 2 | 18 |

*Bolzano EGA HPP – Concrete saddle conditions*
