# A small propeller turbine to supply drinkable water to the small town of Kahemba (RDC)

**Giovanni Frosio**  
STUDIO FROSIO S.R.L.  
Via P. F. Calvi, 9  
25123 - Brescia  
ITALY

**Francesco Pozzi**  
TECHYDRO S.R.L.  
Via Rovereto, 3  
20871 - Vimercate (MI)  
ITALY

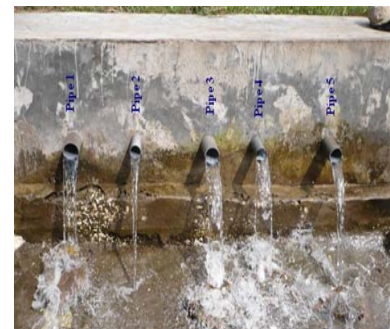
Fig. 2 - Flow rate measured at the spring.

The following table shows that the source flow rate is remarkably constant and little affected by the seasonal rainfall trends.

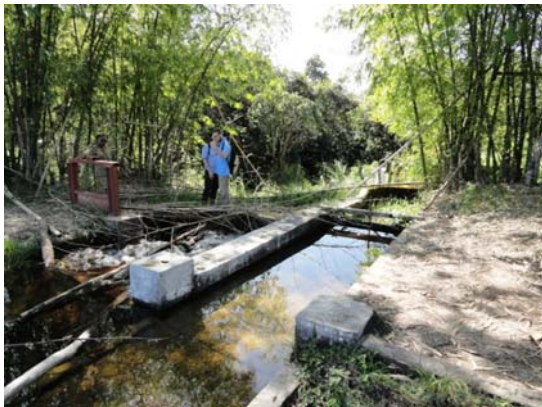
Fig. 3 - Existing intake structure on the Kayoke torrent.

The option of using a mini-hydro systems derives from the presence, near the aforesaid Shamusenge source, of the Kayoke stream where, approximately 3 km upstream of the source, there was an old intake with its hydraulic wheel which used to operate a volumetric pump for supplying a small discharge to a nearby Catholic mission.

Meanwhile the mission was abandoned, but the intake works remained in a good conservation state.

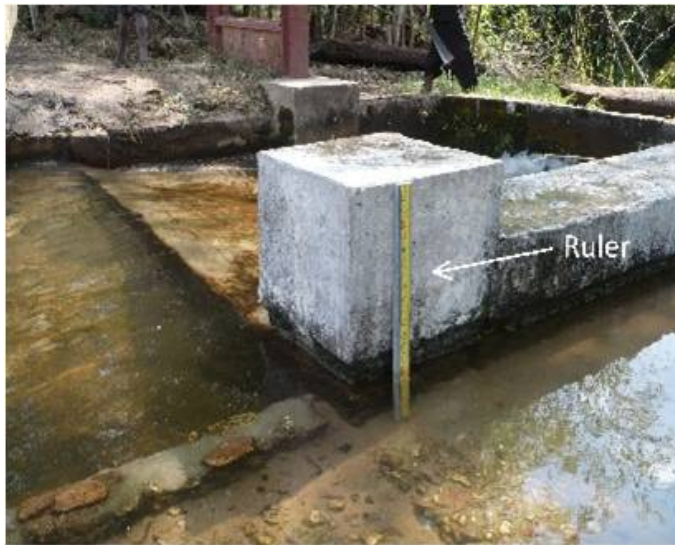
Fig. 4 - Torrent flow rate measures.

The following table shows that the flow rate never goes under 90 l/s during the year.

Consequently the rated flow of the plant had to be less than the minimum available in the watercourse, which never goes under 90 l/s, as it can be seen in the table of Fig. 4.

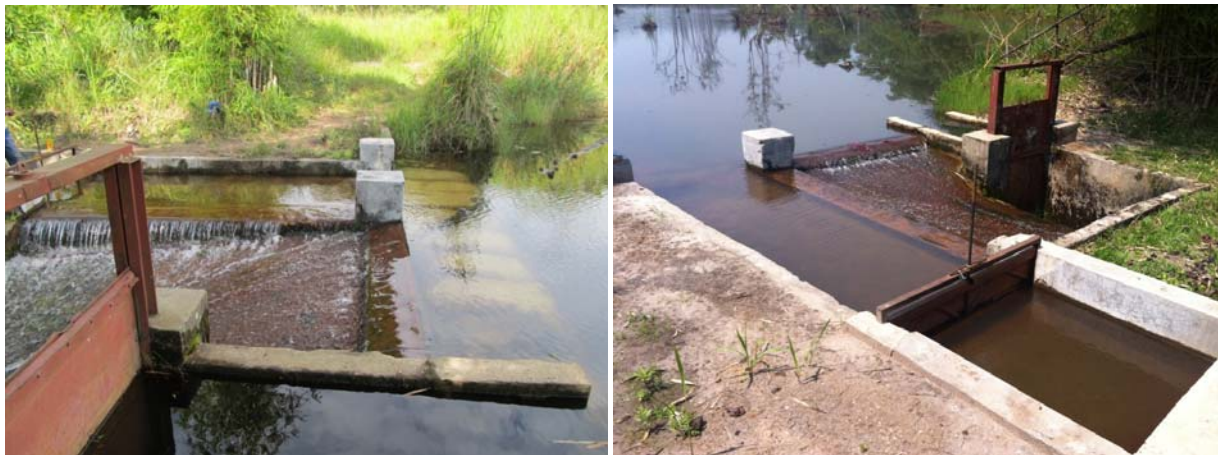
Fig. 5 - Intake structures rehabilitated and upgraded.

The existing intake structures have been modified to realise the penstock inlet under an appropriate water height, In this occasion the spillways' length has been nearly doubled to increase safety in case of intense rainfalls.

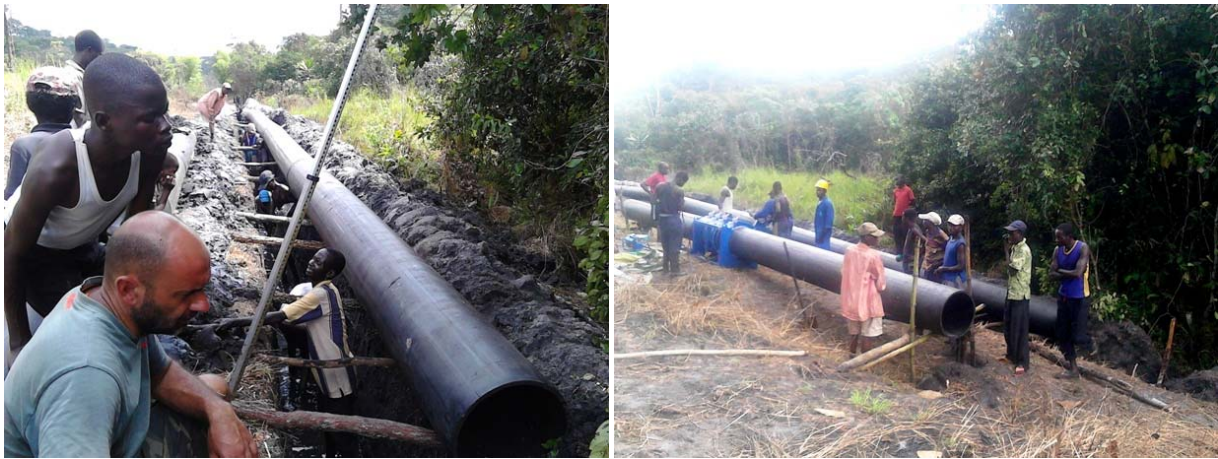
*Fig. 10 - Penstock erecting activities.*

In Kahemba area there's no working site vehicle available to carry out the preliminary works of topsoil excavation for the erection of the pipes on often uneven grounds.

Therefore we had to provide for single pieces to be assembled with a compatible weight for exclusively manual operations and also for appropriate methods for laying the pipes on the ground.

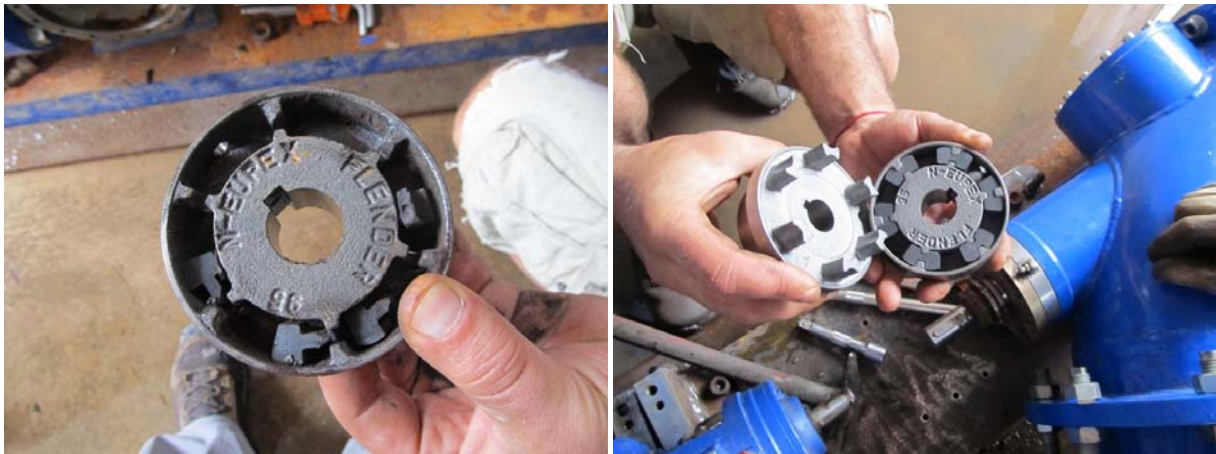
*Fig. 11 - Coupling joint damaged on left and the new one on right.*

In spite of the cautions taken in the design and construction phase, around one week after the first commissioning, which took place in December 2015, the elastic joint between the pump and the turbine was damaged by a strong

misalignment occurring in the transport or in the assembly phases. Steps were taken to substitute the joint, realign the shaft and then put the unit back to work.

The pumping unit was perfectly assembled in the workshop on a unique steel frame in order to avoid any alignment operation on site. Actually a misalignment occurred, probably caused by the difficult transport conditions or during the assembling operation of the last pipe close to power house.

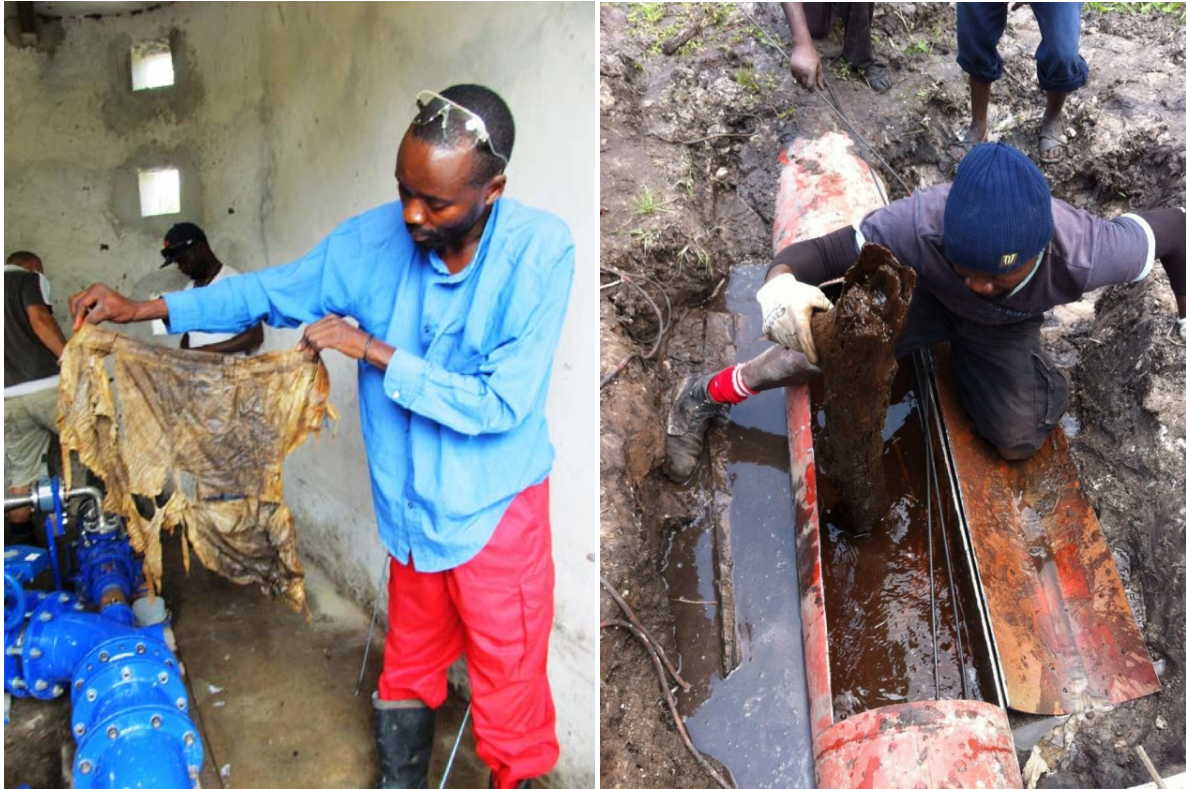
*Fig. 13 - Extraneous materials in the penstock ...*

Nevertheless the head losses in the penstock kept 40% higher than expected. By manometric measurements in different points of the pipeline, the critical point was identified in the final stretch of the penstock. Therefore we decided to open it and actually we found and removed a rag and a big piece of wood, that evidently entered in the penstock during the erection works, as the inlet is protected by a 20 x 20 mm screen.

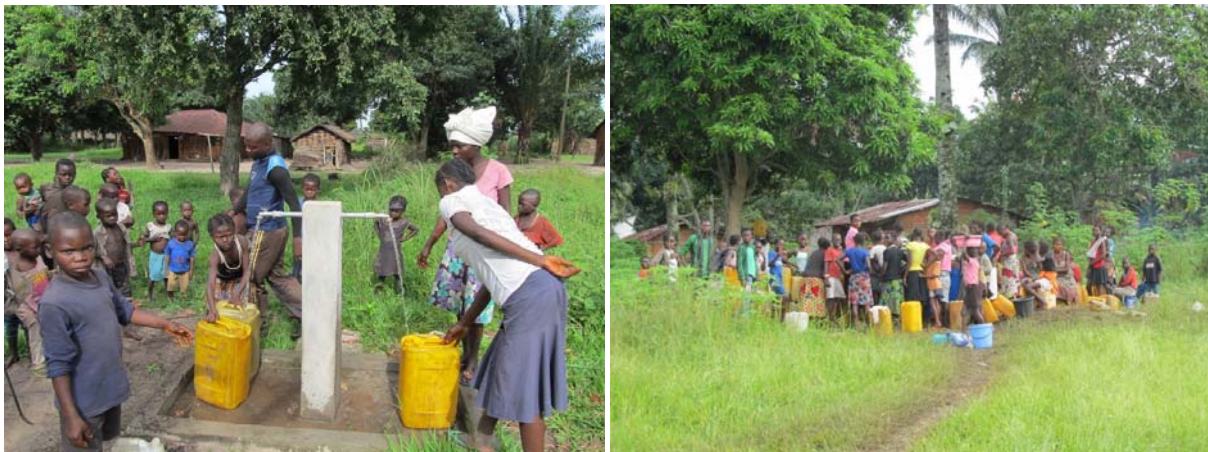
Fig. 14 - Water distribution in the town.

Thanks to the use of a RES to provide energy for the pump, the management costs are very low and therefore compatible with the paying capacity of all the people in Kahemba.
